**Flood Control Project Maintenance  
Levee Inspections**

**2018 Channel Summary Report**

**Madera County FCWCA**

**Ash Slough**

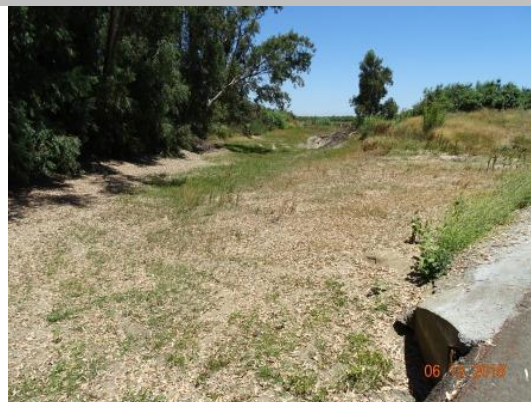
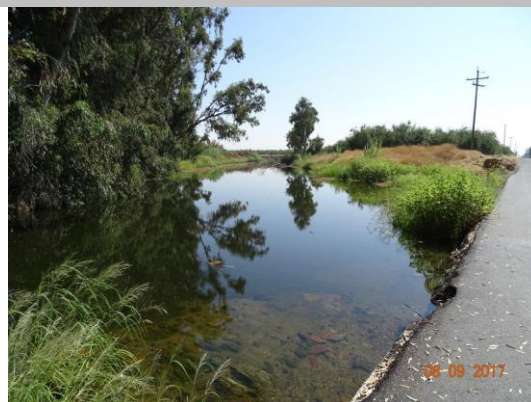
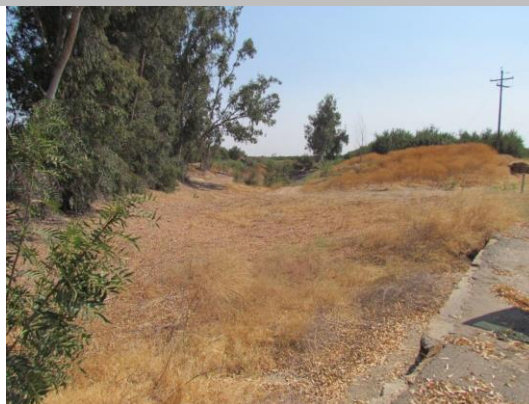
Check Point / View				
Ave 22 / Up				
Rating **	A	Issue No.	61	GPS Lat/Long
Issue Type +	Ma	Location *		37.069003 °
Category	Rivers, Channels & Designated Flood			-120.278523 °
Item	Vegetation & Obstructions			
DWR ID	DWR_NA0011_39_c_2016_61			
Action/Comments				
Inspector Comments: Minimal vegetation, but may not obstruct the flow of the channel.

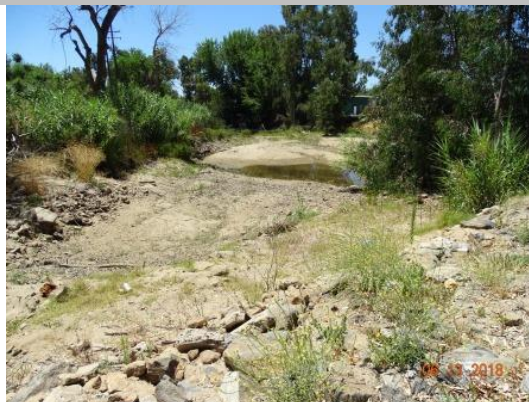
Photo 1 of 4 : CH\_2018\_NA0011\_39\_66\_20180615\_00068.jpg

Check Point / View				
<b>Ave 22 / Down</b>				
Rating **	M	Issue No.	66	GPS Lat/Long
Issue Type +	Ma	Location *		37.069003 °
Category	Rivers, Channels & Designated Flood			-120.278523 °
Item	Vegetation & Obstructions			
DWR ID	DWR_NA0011_39_c_2016_66			
Action/Comments				
Inspector Comments: There are Trees growing right at the low water crossing that should be removed from the channel.

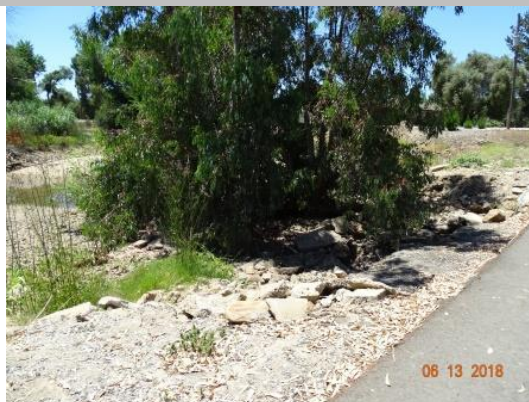
Photo 2 of 4 : CH\_2018\_NA0011\_39\_66\_20180615\_00069.jpg

View downstream of large trees in the channel. (2018)

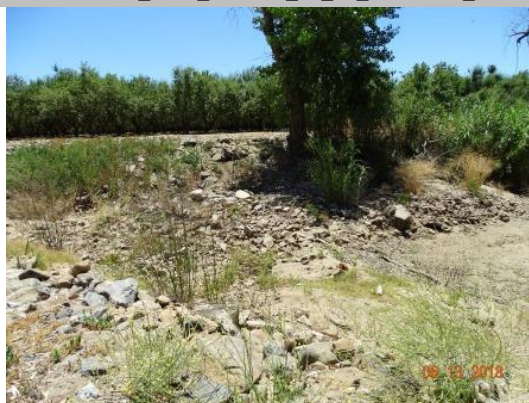
Photo 1 of 2 : CH\_2018\_NA0011\_39\_69\_20180615\_00070.jpg

Rating **	A	Issue No.	<b>69</b>	GPS Lat/Long
Issue Type +	Ma	Location *		37.069003 °
Category	Rivers, Channels & Designated Flood			-120.278523 °
Item	Revetments			
DWR ID	DWR_NA0011_39_c_2016_69			
Action/Comments				
Inspector Comments: Recently the LMA has placed additional riprap to repair the site.

View of downstream right bank revetment and revetment in the channel.  
(2018)

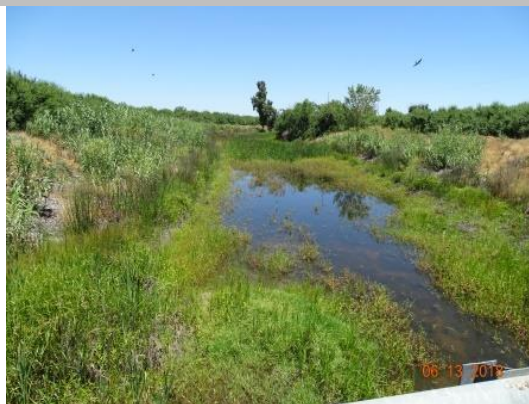
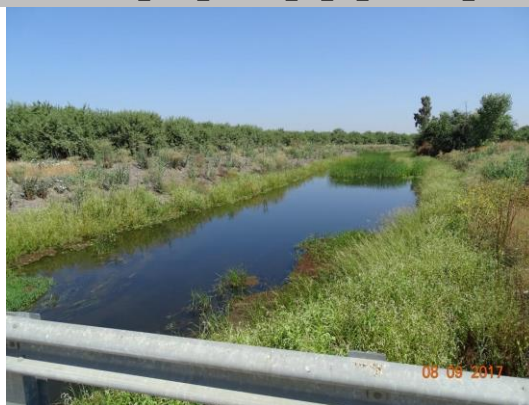
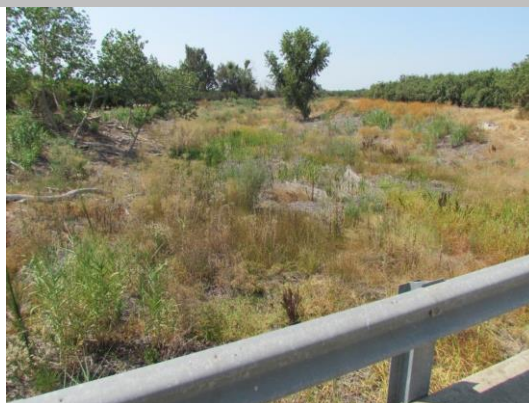
Rating **	A	Issue No.	71	GPS Lat/Long
Issue Type +	Ma	Location *		37.054470 °
Category	Rivers, Channels & Designated Flood			-120.284380 °
Item	Vegetation & Obstructions			
DWR ID	DWR_NA0011_39_c_2016_71			
Action/Comments				
Inspector Comments: Some minor vegetation was found, but the flow does not appear impeded.

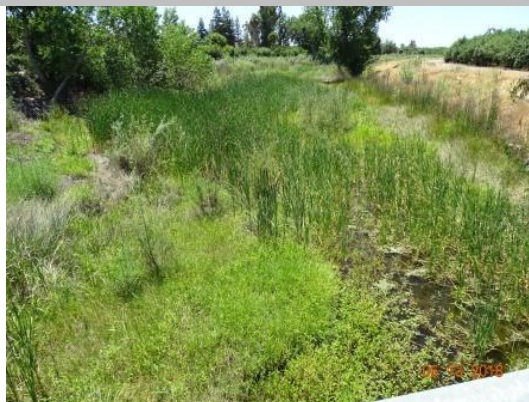
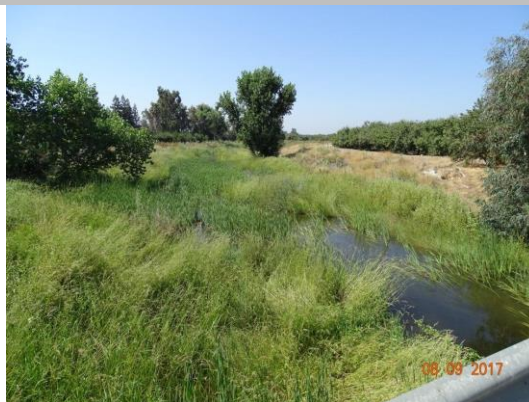
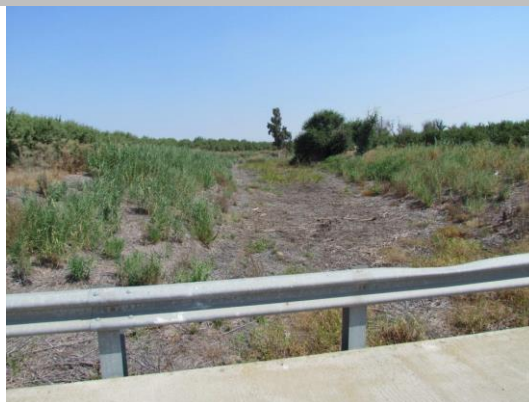
Check Point / View				
Ave 21 / Down				
Rating **	M	Issue No.	76	GPS Lat/Long
Issue Type +	Ma	Location *		37.054470 °
Category	Rivers, Channels & Designated Flood			-120.284380 °
Item	Vegetation & Obstructions			
DWR ID	DWR_NA0011_39_c_2016_76			
Action/Comments				
Inspector Comments: Cattails have grown significantly and are across the whole channel.

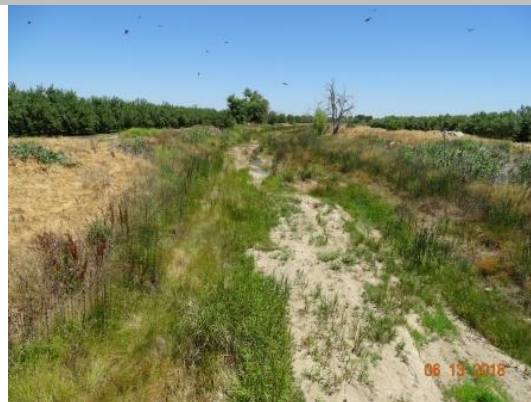
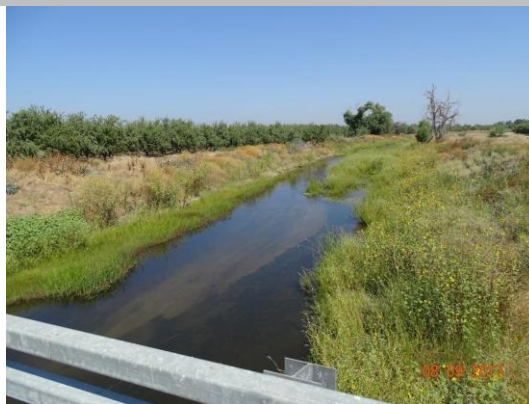
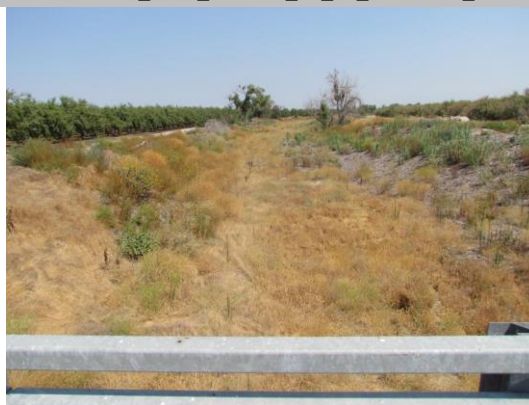
Inspector Comments: Minimal vegetation was present.

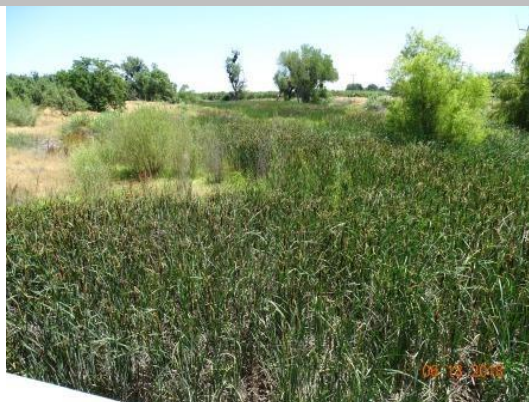
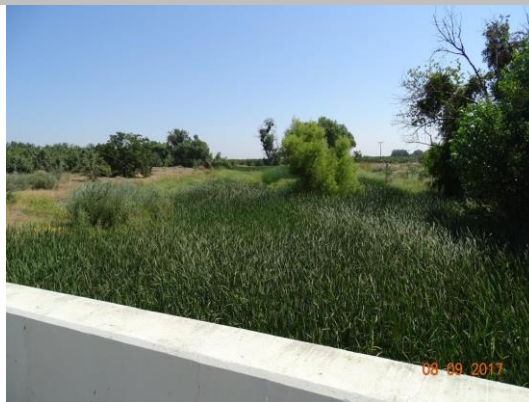
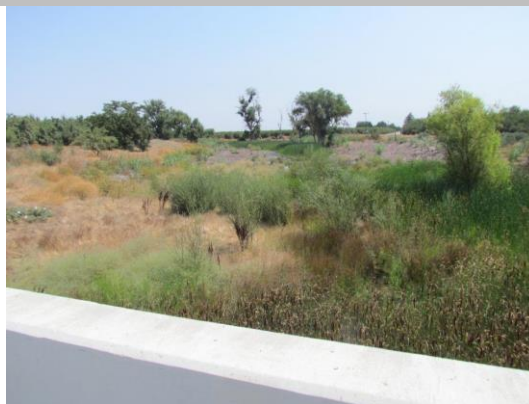
Check Point / View				
Rd 13 / Up				
Rating **	M	Issue No.	91	GPS Lat/Long
Issue Type +	Ma	Location *		37.025350 °
Category	Rivers, Channels & Designated Flood			-120.310447 °
Item	Vegetation & Obstructions			
DWR ID	DWR_NA0011_39_c_2016_91			
Action/Comments				
Inspector Comments: Looking upstream of bridge crossing there is vegetation present in channel that need to be maintained.

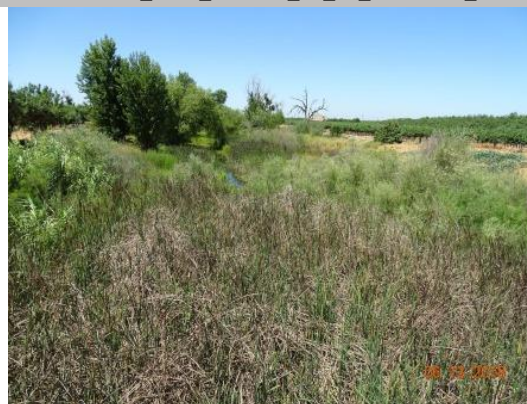
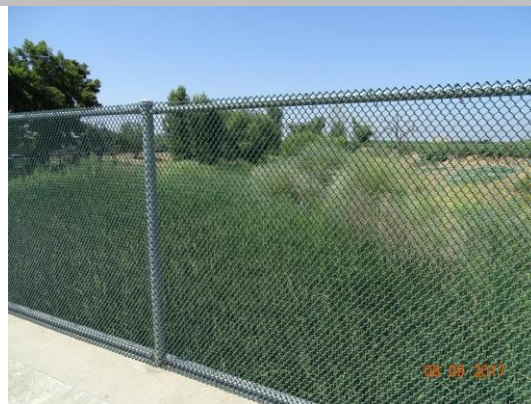
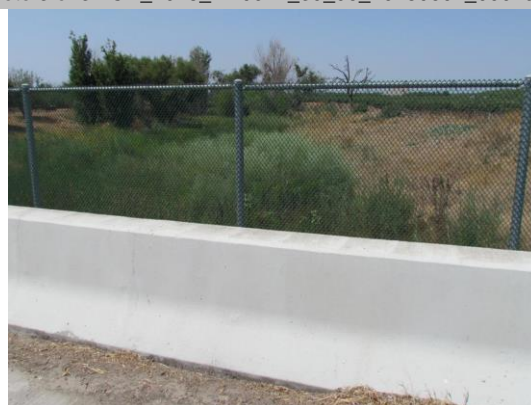
Check Point / View				
<b>Rd 13 / Down</b>				
Rating **	M	Issue No.	96	GPS Lat/Long
Issue Type +	Ma	Location *		37.025350 °
Category	Rivers, Channels & Designated Flood			-120.310447 °
Item	Vegetation & Obstructions			
DWR ID	DWR_NA0011_39_c_2016_96			
Action/Comments				
Inspector Comments: The vegetation in channel should be controlled downstream of bridge crossing.

Looking downstream at the channel. (2018)

View of the vegetation in the channel looking downstream. Summer 2017

Berenda Slough from Road 13.

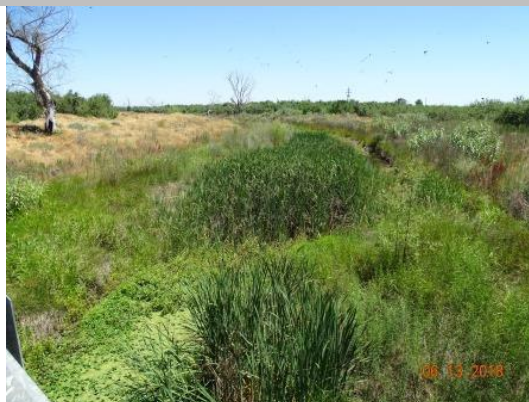
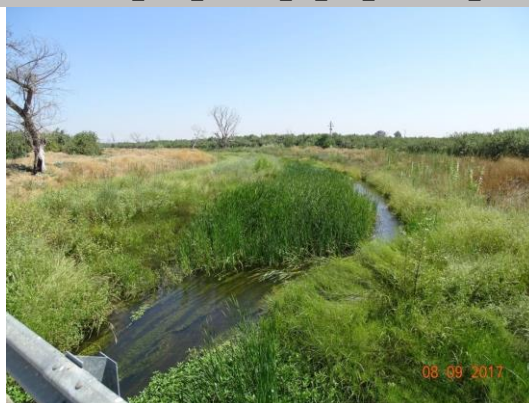
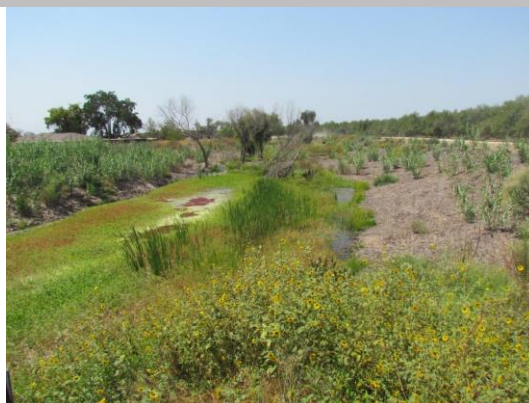
Looking upstream at the channel. (2018)

View of the upstream of the channel during 2017 inspection.

Berenda Slough looking upstream from Road 14.

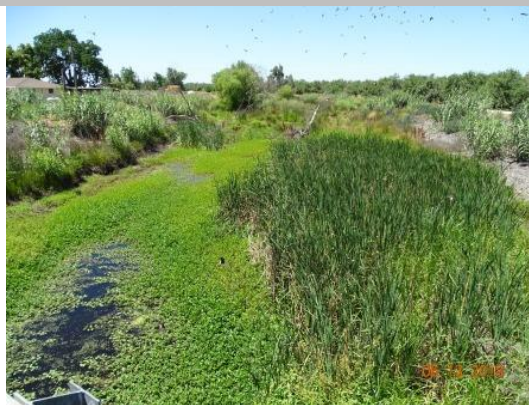
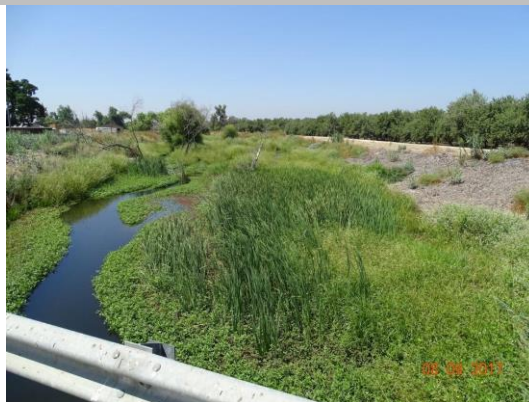
Check Point / View				
Road 14 / Down				
Rating **	M	Issue No.	106	GPS Lat/Long
Issue Type +	Ma	Location *		37.050214 °
Category	Rivers, Channels & Designated Flood			-120.292481 °
Item	Vegetation & Obstructions			
DWR ID	DWR_NA0011_39_c_2016_106			
Action/Comments				
Inspector Comments: Cattails and arundo was present in the channel but does not impede the flow in the channel.

Looking downstream at the channel. (2018)

View of the vegetation in the channel looking downstream. Summer 2017

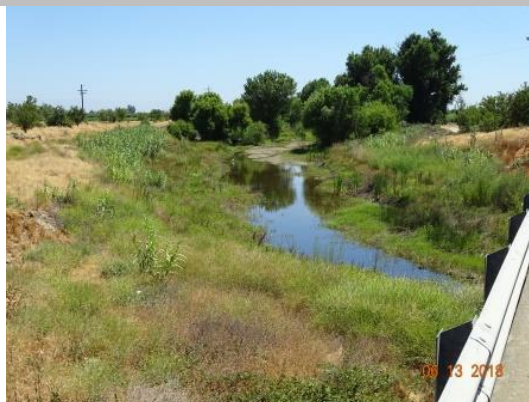
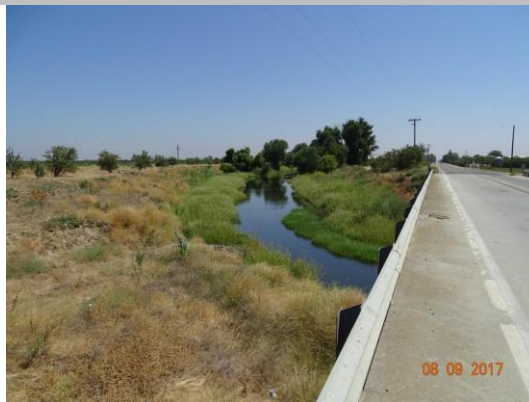
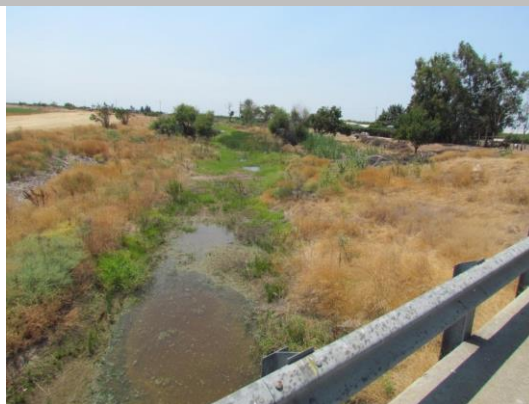
Inspector Comments: Minimal vegetation was found, but the flow is not impeded.

Looking upstream at the channel. (2018)

View of the channel looking upstream during 2017 inspection.

Berenda Slough looking upstream from Avenue 18 1/2 bridge crossing.

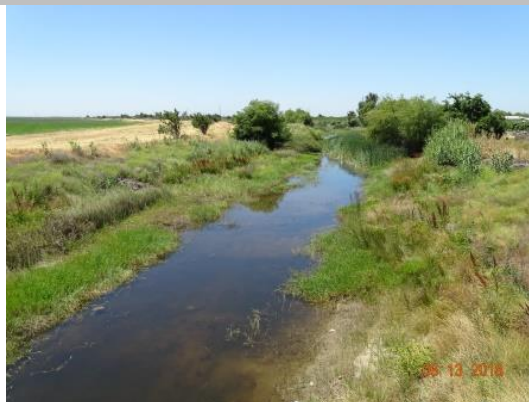
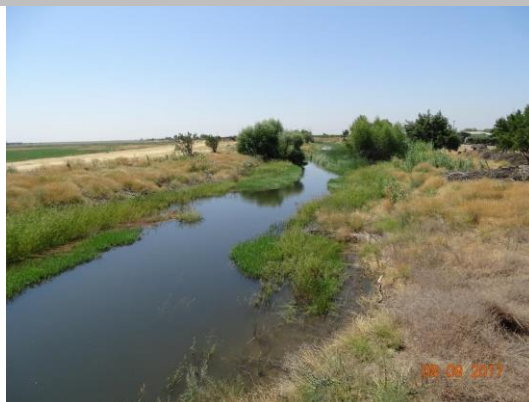
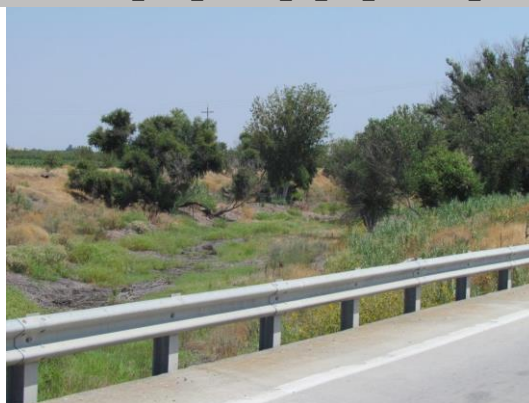
Check Point / View				
<b>Ave 18 1/2 / Down</b>				
Rating **	A	Issue No.	116	GPS Lat/Long
Issue Type +	Ma	Location *		37.018173 °
Category	Rivers, Channels & Designated Flood			-120.326250 °
Item	Vegetation & Obstructions			
DWR ID	DWR_NA0011_39_c_2016_116			
Action/Comments				
Inspector Comments: Minimal vegetation was found, but the flow was not impeded.

Looking downstream at the channel. (2018)

View of the channel looking downstream. Summer 2017

Berenda Slough looking downstream from the Avenue 18 1/2 crossing.

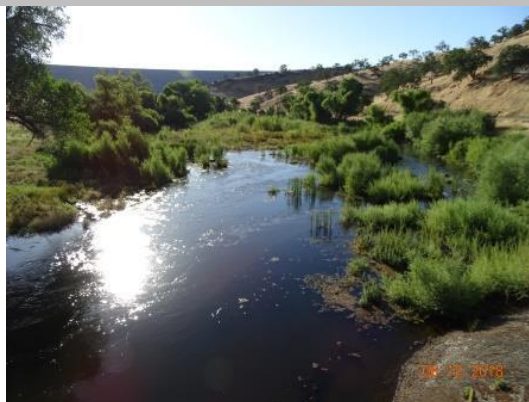
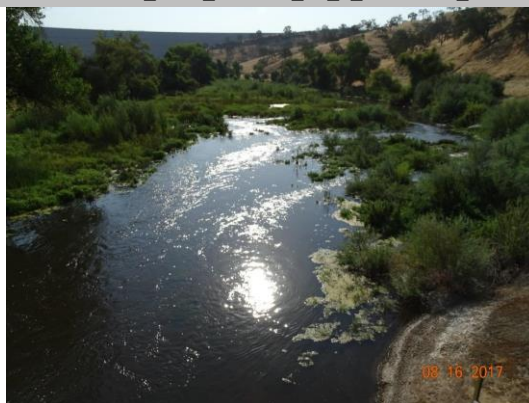
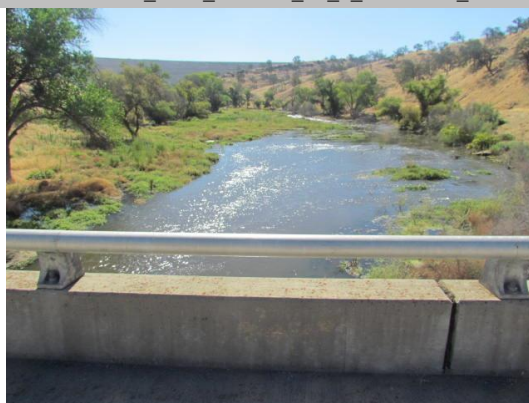
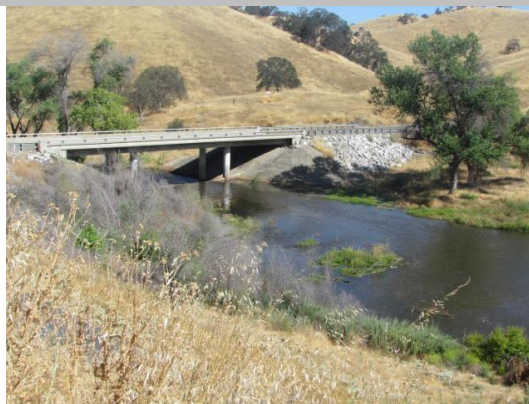
Looking east (upstream) at channel downstream from dam. (2018)

Looking east (upstream) at the channel on the downstream side of the dam.

Looking east (upstream) at channel downstream from Dam. (2016)

Inspector Comments: No vegetation or obstructions present that would impede the flow.

Looking west just downstream from Dam.

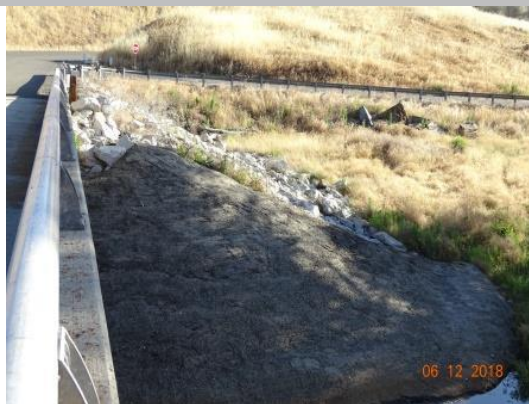
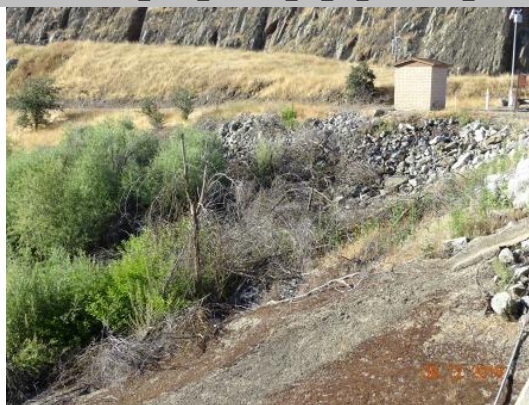
Inspector Comments: Revetment appears to be properly maintained.

Upstream right bank revetment. (2018)

Upstream left bank revetment. (2018)

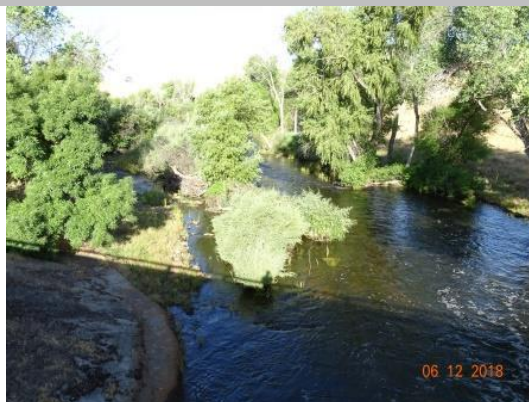
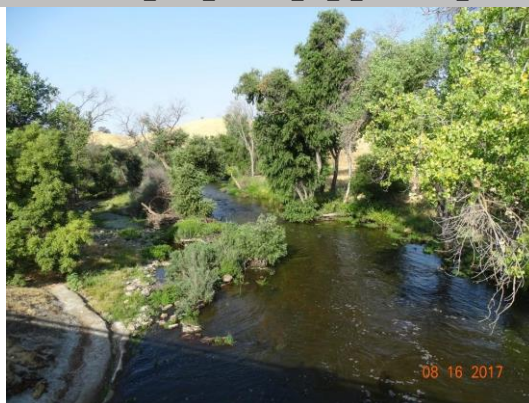
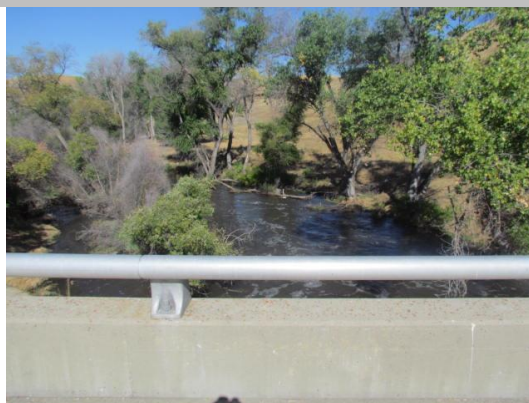
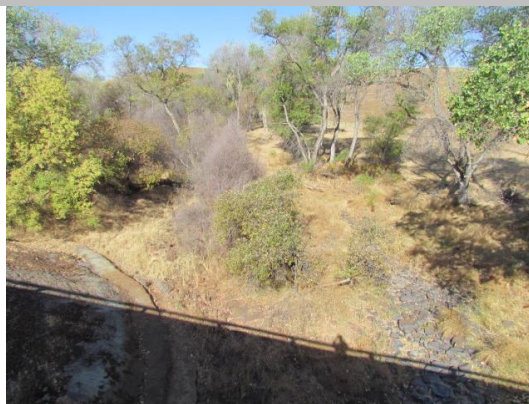
Looking west (downstream) at channel downstream of dam. (2018)

Looking west (downstream) at channel downstream from the dam.

Looking west (downstream) at channel downstream from Dam. (2016)

Inspector Comments: No vegetation or obstructions present that would impede the flow.

Looking west (downstream) at channel downstream from Dam. (2015)

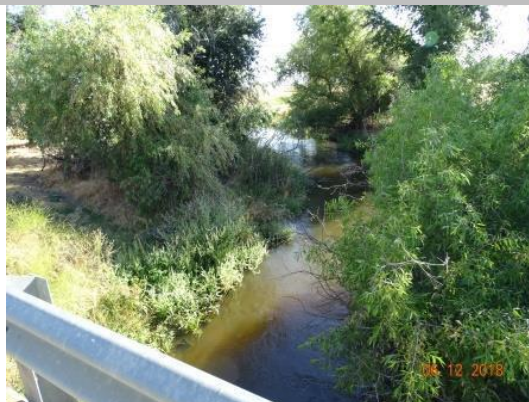
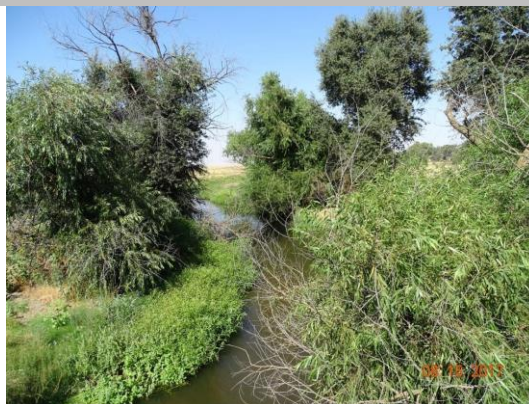
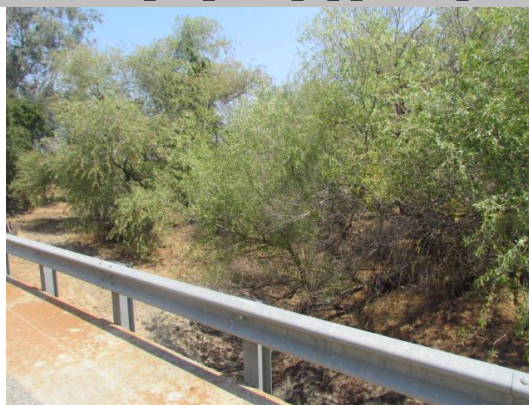
Looking upstream at the channel from Santa Fe Dr. (2018)

Looking northeast (upstream) at the channel from Santa Fe Dr.

Looking east (upstream) at channel from Santa Fe Dr.

Inspector Comments: Trees established in channel near bridge should be removed.

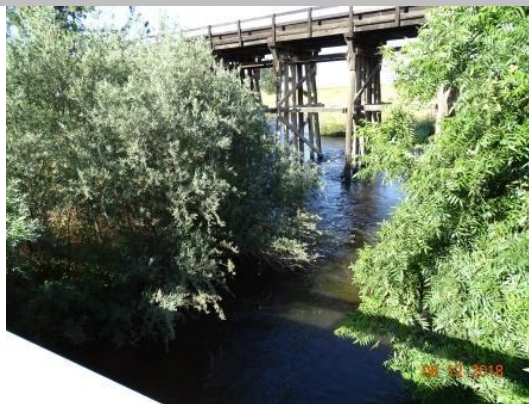
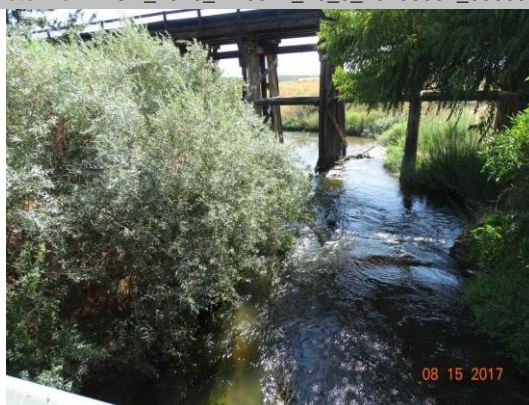
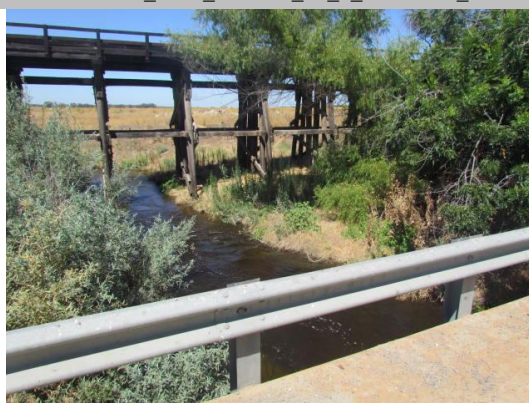
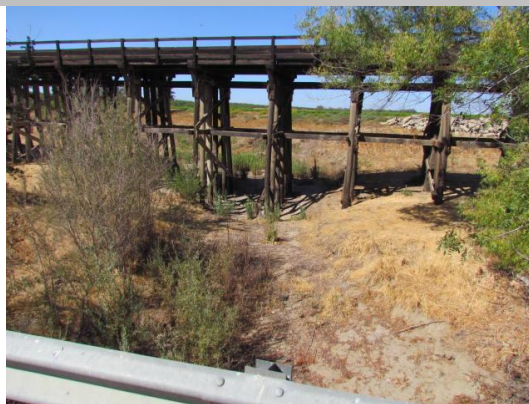
Looking downstream at the channel from Santa Fe Dr. (2018)

Looking southwest at the channel from Santa Fe Dr.

Looking west (downstream) at channel from Santa Fe Dr. (2016)

Looking west (downstream) at channel from Santa Fe Dr. (2015)

Inspector Comments: Control tree growth in channel near bridge.

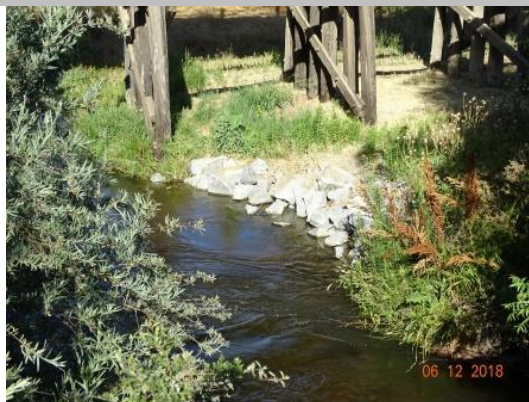
Inspector Comments: Some revetment on the right bank upstream of railroad bridge. Looks in good condition.

Revetment on downstream right bank. (2018)

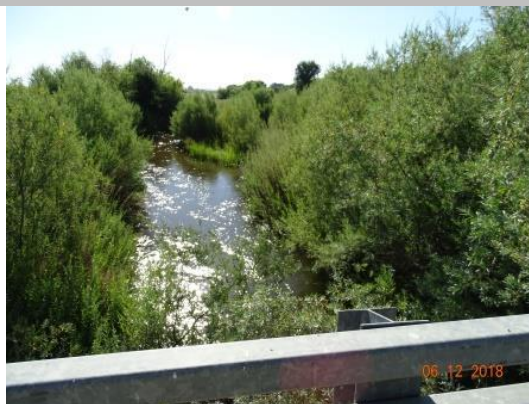
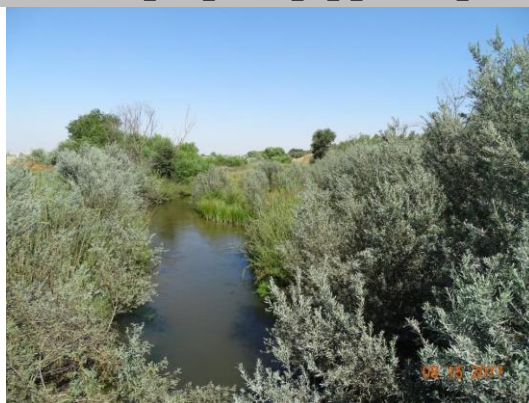
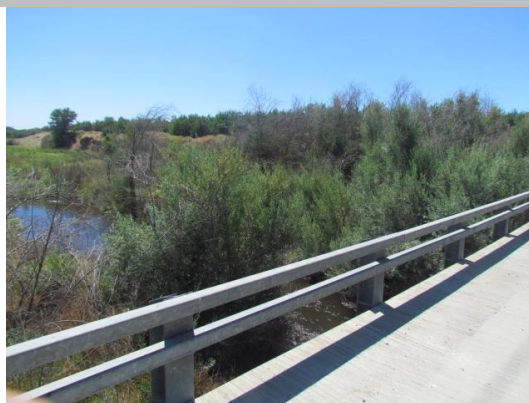
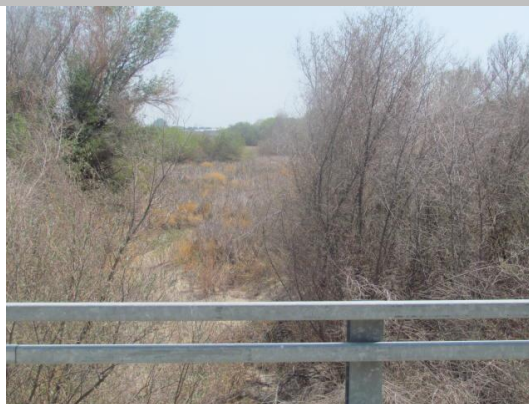
Looking upstream at channel from White Rock Rd.

Looking east(upstream) at channel from White Rock Rd.

Looking east (upstream) at channel from White Rock Road. (2016)

Looking east (upstream) at channel from White Rock Road. (2015)

Inspector Comments: Established trees near bridge should be controlled.

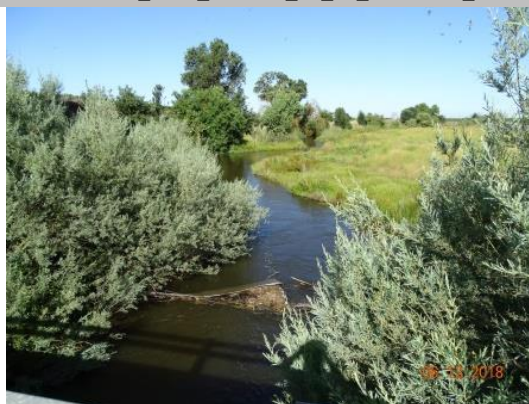
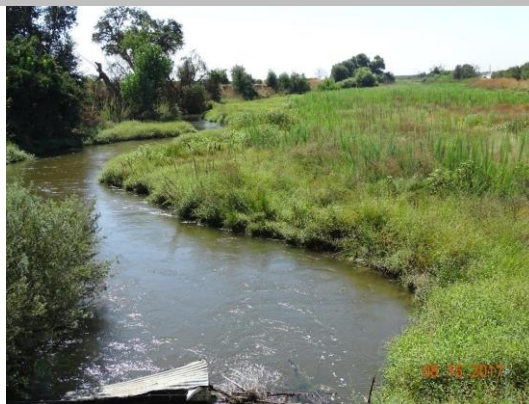
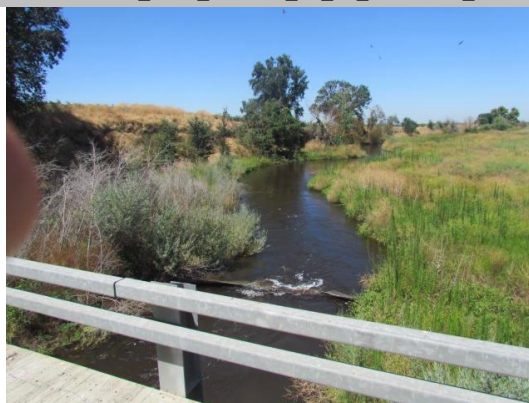
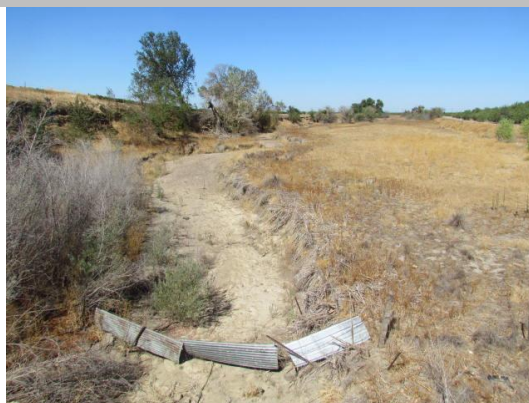
Looking downstream at channel from Road 19. (2018)

Looking west (downstream) at the channel from White Rock Rd.

Looking west (downstream) at channel from Road 19. (2016)

Looking west (downstream) at channel from Road 19. (2015)

Inspector Comments: Established trees near bridge should be controlled.

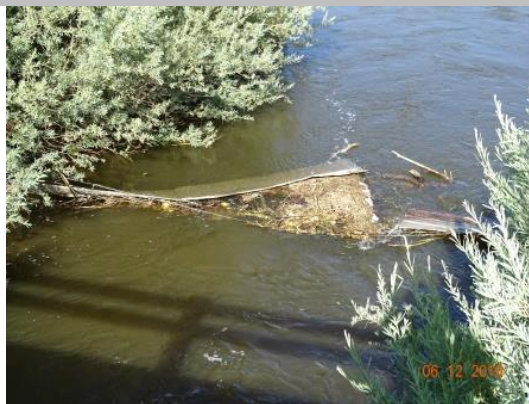
Photo 1 of 1 : CH\_2018\_NA0011\_40\_14\_20180614\_00086.jpg

Inspector Comments: Fence with corrugated metal going across the channel does not appear to block flow.

Corrugated metal fence in the middle of the channel. (2018)

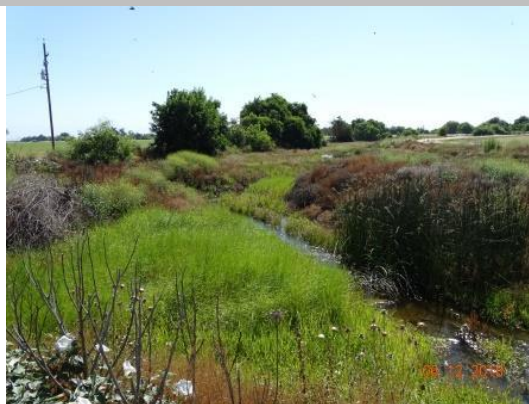
Photo 1 of 5 : CH\_2018\_NA0011\_40\_21\_20180614\_00087.jpg

Inspector Comments: Established vegetation near bridge should be removed.

Looking upstream at the channel from Rd 13. (2018)

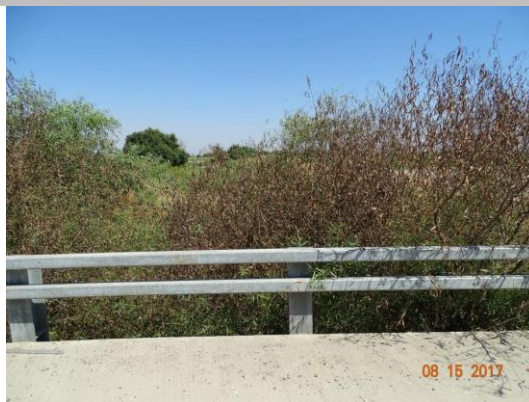
Photo 2 of 5 : CH\_2018\_NA0011\_40\_21\_20180601\_00025.jpg

Inspector Comments: Established vegetation near bridge should be removed.

Looking northeast (upstream) at the channel from Rd 13.

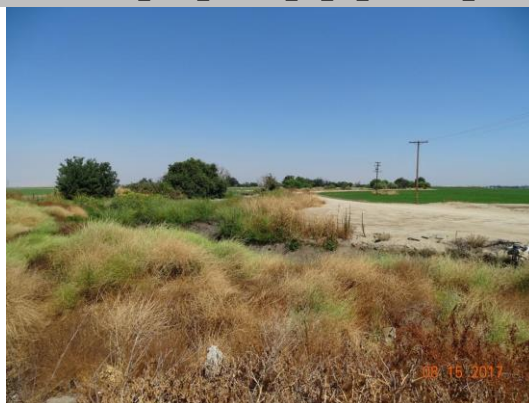
Photo 3 of 5 : CH\_2018\_NA0011\_40\_21\_20180601\_00026.jpg

Looking northeast (upstream) at the channel from Rd 13.

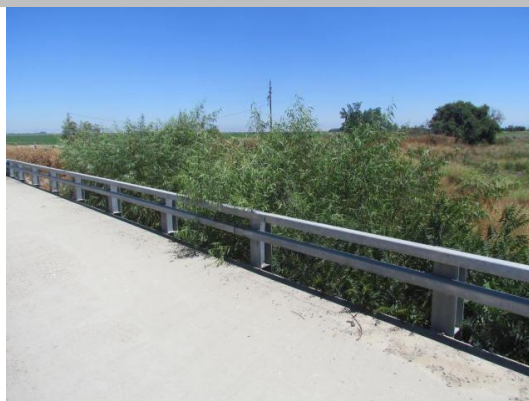
Photo 4 of 5 : CH\_2018\_NA0011\_40\_21\_20180601\_00027.jpg

Looking east (upstream) at channel from Road 13. (2016)

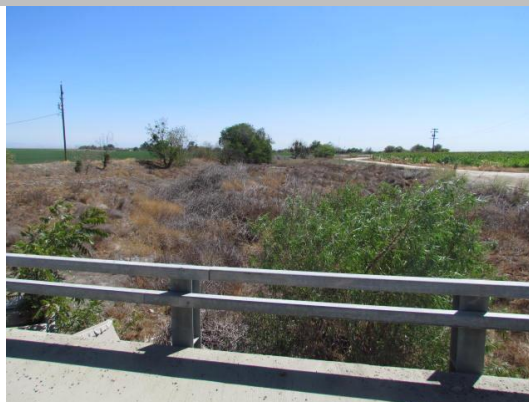
Photo 5 of 5 : CH\_2018\_NA0011\_40\_21\_20180601\_00028.jpg

Inspector Comments: Established vegetation near bridge should be removed.

Looking east (upstream) at channel from Road 13. (2015)

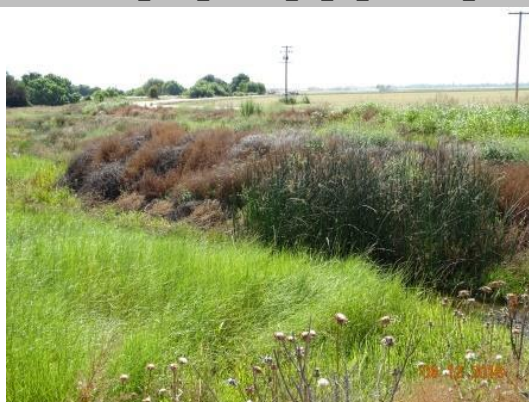
Photo 1 of 1 : CH\_2018\_NA0011\_40\_22\_20180614\_00088.jpg

Inspector Comments: Shoaling with non-aquatic grasses is present in the channel should be controlled.

View of upstream shoal with non-aquatic grasses. (2018)

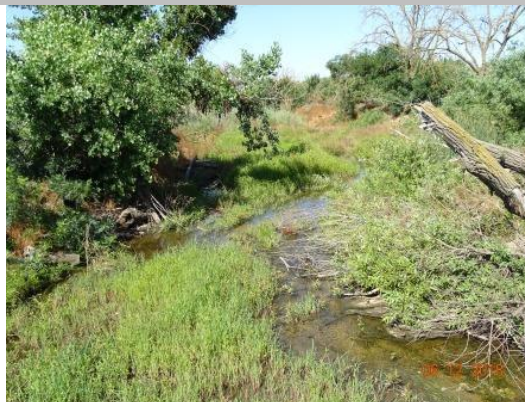
Photo 1 of 2 : CH\_2018\_NA0011\_40\_24\_20180614\_00089.jpg

Inspector Comments: Established trees and vegetation near bridge should be removed.

Downstream view of channel from Rd 13. (2018)

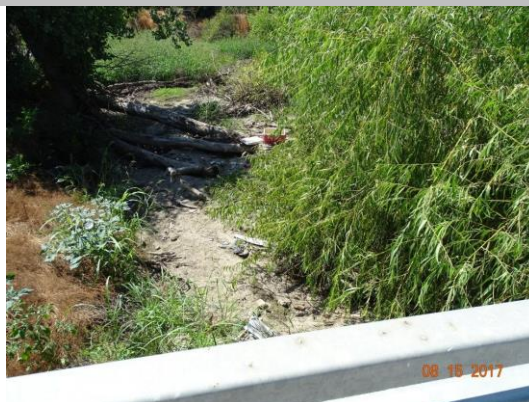
Photo 2 of 2 : CH\_2018\_NA0011\_40\_24\_20180601\_00034.jpg

Rating **	M	Issue No.	24 (cont)	GPS Lat/Long
Issue Type +	Ma	Location *		37.140708 °
Category	Rivers, Channels & Designated Flood			-120.310961 °
Item	Vegetation & Obstructions			
DWR ID	DWR_NA0011_40_c_2012_24			
Action/Comments				
Inspector Comments: Established trees and vegetation near bridge should be removed.

Looking west (downstream) at the channel from Rd 13.

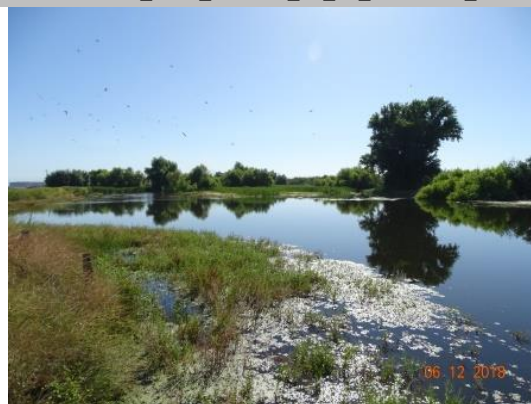
Photo 1 of 2 : CH\_2018\_NA0011\_40\_15\_20180614\_00090.jpg

Check Point / View				
<b>RD 15 / Up</b>				
Rating **	A	Issue No.	15	GPS Lat/Long
Issue Type +	Ma	Location *		37.151660 °
Category	Rivers, Channels & Designated Flood			-120.274370 °
Item	Vegetation & Obstructions			
DWR ID	DWR_NA0011_40_c_2012_15			
Action/Comments				
Inspector Comments: No vegetation issues present.

Looking upstream at the channel from Rd 15. (2018)

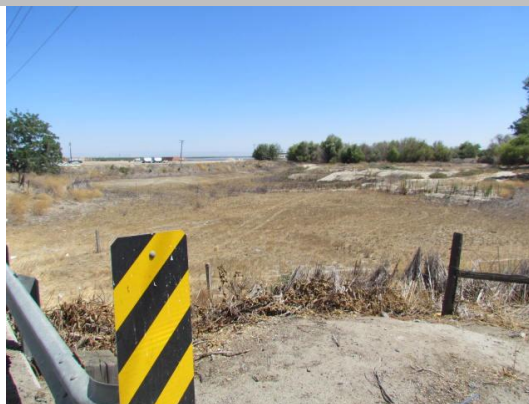
Photo 2 of 2 : CH\_2018\_NA0011\_40\_15\_20180601\_00021.jpg

Rating **	A	Issue No.	15 (cont)	GPS Lat/Long
Issue Type +	Ma	Location *		37.151660 °
Category	Rivers, Channels & Designated Flood			-120.274370 °
Item	Vegetation & Obstructions			
DWR ID	DWR_NA0011_40_c_2012_15			
Action/Comments				
Inspector Comments: No vegetation issues present.

Looking east (upstream) at channel from Road 15. (2015)

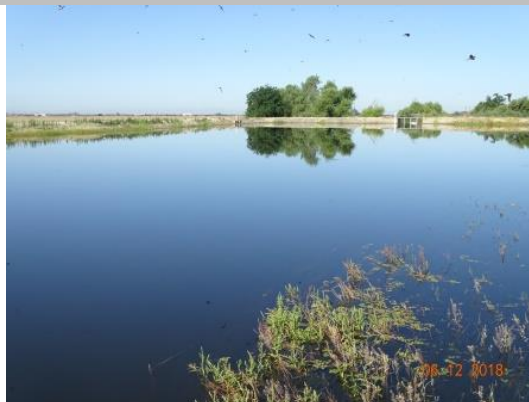
Photo 1 of 2 : CH\_2018\_NA0011\_40\_18\_20180614\_00091.jpg

Inspector Comments: No vegetation or obstructions present to impede flow.

Looking downstream at check dam from Rd 15. (2018)

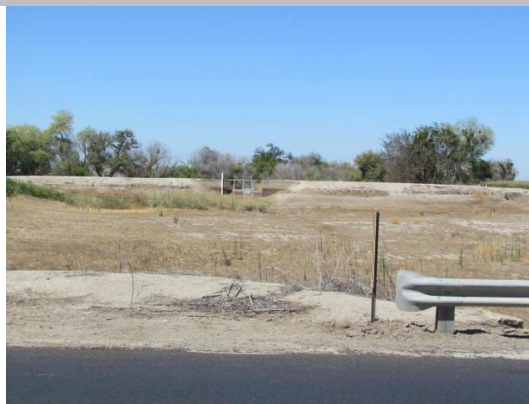
Photo 2 of 2 : CH\_2018\_NA0011\_40\_18\_20180601\_00024.jpg

Check Point / View				
RD 15 / Down (cont)				
Rating **	A	Issue No.	18 (cont)	GPS Lat/Long
Issue Type +	Ma	Location *		37.151660 °
Category	Rivers, Channels & Designated Flood			-120.274370 °
Item	Vegetation & Obstructions			
DWR ID	DWR_NA0011_40_c_2012_18			
Action/Comments				
Inspector Comments: No vegetation or obstructions present to impede flow.

Looking west (downstream) at Check Dam from Road 15. (2015)

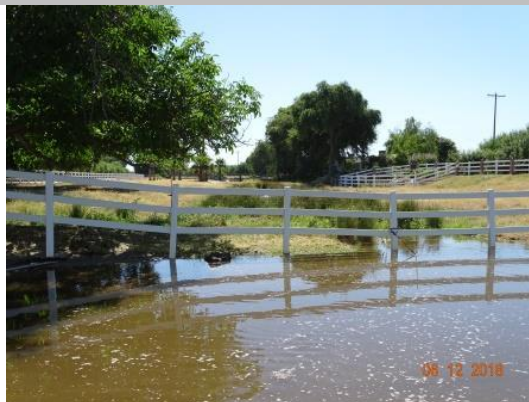
Photo 1 of 2 : CH\_2018\_NA0011\_40\_27\_20180614\_00092.jpg

Check Point / View				
<b>Low Water Crossing at Rd 11 / Up</b>				
Rating **	A	Issue No.	27	GPS Lat/Long
Issue Type +	Ma	Location *		37.123770 °
Category	Rivers, Channels & Designated Flood			-120.347120 °
Item	Vegetation & Obstructions			
DWR ID	DWR_NA0011_40_c_2012_27			
Action/Comments				
Inspector Comments: Vegetation is present but would not likely impede the flow in the channel.

Looking upstream at channel from low water crossing on Rd 11. (2018)

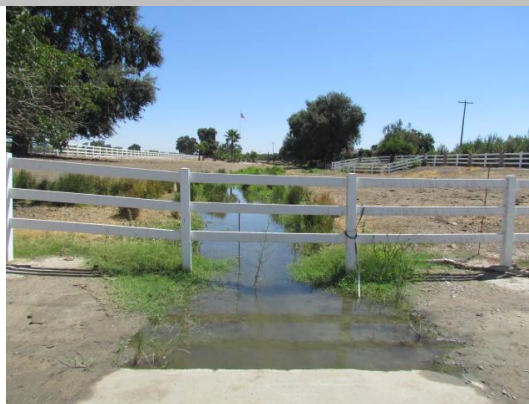
Photo 2 of 2 : CH\_2018\_NA0011\_40\_27\_20180601\_00039.jpg

Rating **	A	Issue No.	27 (cont)	GPS Lat/Long
Issue Type +	Ma	Location *		37.123770 °
Category	Rivers, Channels & Designated Flood			-120.347120 °
Item	Vegetation & Obstructions			
DWR ID	DWR_NA0011_40_c_2012_27			
Action/Comments				
Inspector Comments: Vegetation is present but would not likely impede the flow in the channel.

Looking east (upstream) at channel from Road 11. (2015)

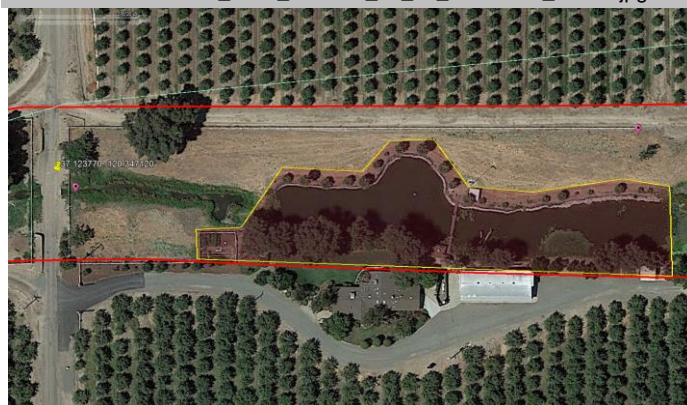
Photo 1 of 3 : CH\_2018\_NA0011\_40\_29\_20180718\_00102.jpg

Inspector Comments: Fence across channel should be breakway fence. Landowner planted palm trees, installed fencing deck and bridge, lagoon and garden within the channel.

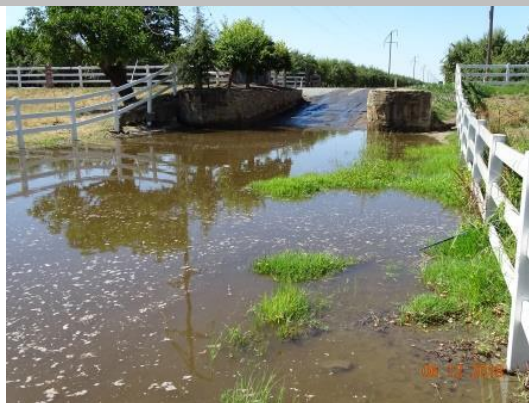
Photo 2 of 3 : CH\_2018\_NA0011\_40\_29\_20180614\_00093.jpg

View of fence on both sides of the low water crossing at Rd 11, looking slightly upstream. (2018)

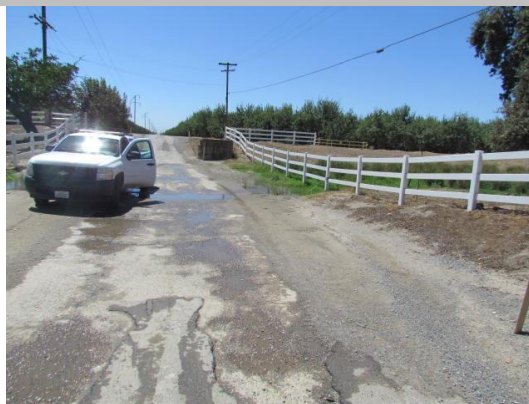
Photo 3 of 3 : CH\_2018\_NA0011\_40\_29\_20180601\_00044.jpg

Inspector Comments: Fence across channel should be breakway fence. Landowner planted palm trees, installed fencing deck and bridge, lagoon and garden within the channel.

Looking south at fence running across channel (2015).

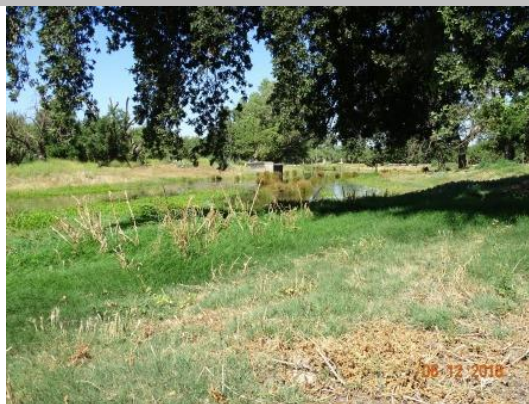
Photo 1 of 3 : CH\_2018\_NA0011\_40\_30\_20180614\_00094.jpg

Inspector Comments: Some vegetation that does not impede flow in the channel.

Looking downstream at channel from low water crossing at Rd 11. (2018)

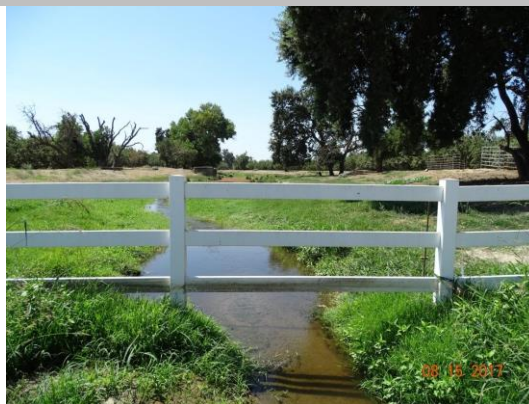
Photo 2 of 3 : CH\_2018\_NA0011\_40\_30\_20180601\_00046.jpg

Rating **	A	Issue No.	30 (cont)	GPS Lat/Long
Issue Type +	Ma	Location *		37.123770 °
Category	Rivers, Channels & Designated Flood			-120.347120 °
Item	Vegetation & Obstructions			
DWR ID	DWR_NA0011_40_c_2012_30			
Action/Comments				
Inspector Comments: Some vegetation that does not impede flow in the channel.

Looking west (downstream) at the channel from the low water crossing at Rd 11.

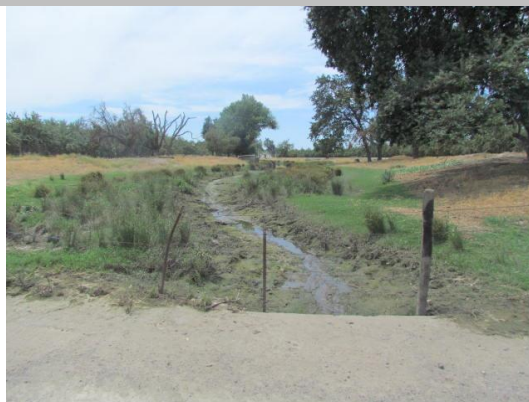
Photo 3 of 3 : CH\_2018\_NA0011\_40\_30\_20180601\_00049.jpg

Looking west (downstream) at channel from Road 11. (2013)

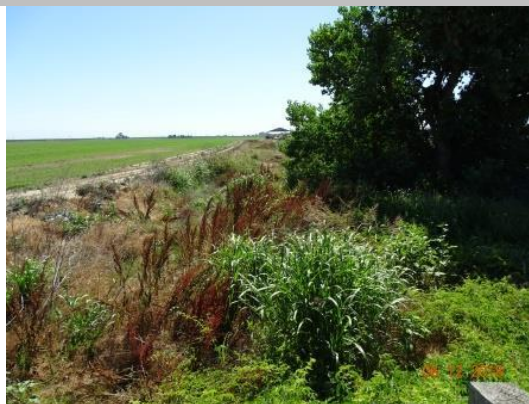
Photo 1 of 2 : CH\_2018\_NA0011\_40\_39\_20180614\_00095.jpg

Inspector Comments: Vegetation is present that could impede flow.

Looking upstream at channel from Road 9. (2018)

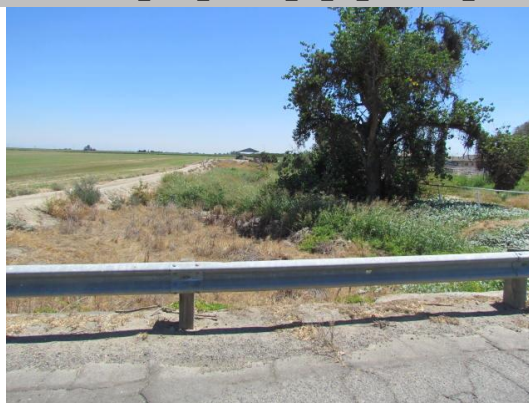
Photo 2 of 2 : CH\_2018\_NA0011\_40\_39\_20180601\_00058.jpg

Looking east (upstream) at channel from Road 9. (2015)

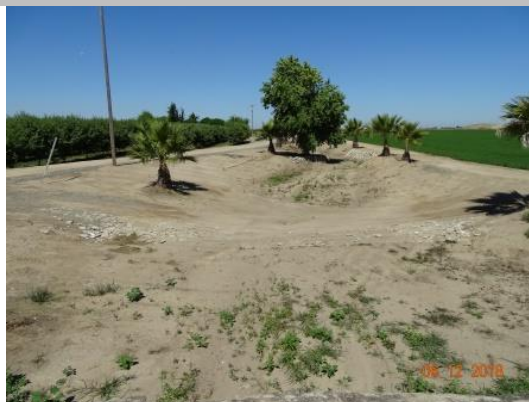
Photo 1 of 2 : CH\_2018\_NA0011\_40\_42\_20180614\_00096.jpg

Rating **	A	Issue No.	42	GPS Lat/Long
Issue Type +	Ma	Location *		37.124145 °
Category	Rivers, Channels & Designated Flood			-120.382724 °
Item	Vegetation & Obstructions			
DWR ID	DWR_NA0011_40_c_2012_42			
Action/Comments				
Inspector Comments: No vegetation or obstructions present to impede flow.

Looking downstream at channel from Rd 9.

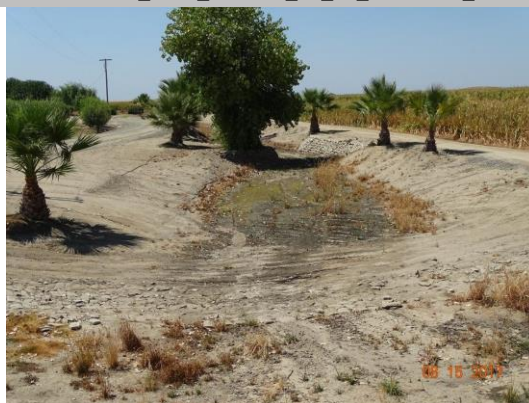
Photo 2 of 2 : CH\_2018\_NA0011\_40\_42\_20180601\_00059.jpg

Looking west (downstream) at the channel from Rd 9.

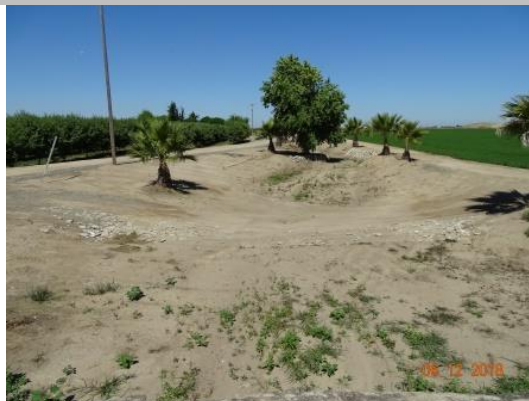
Photo 1 of 2 : CH\_2018\_NA0011\_40\_44\_20180614\_00097.jpg

Inspector Comments: Landowner has planted palm trees on the banks of the channel.

Looking downstream at palm trees the banks of the channel. (2018)

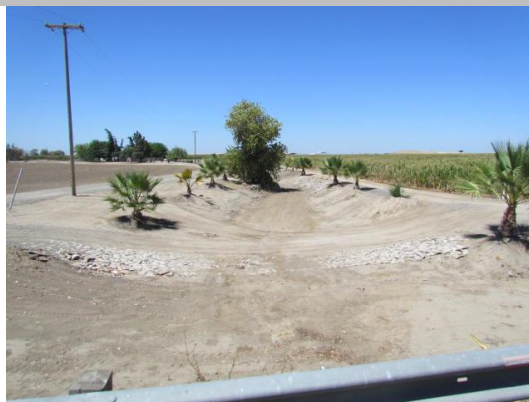
Photo 2 of 2 : CH\_2018\_NA0011\_40\_44\_20180601\_00063.jpg

Inspector Comments: Landowner has planted palm trees on the banks of the channel.

Looking west at plam trees in channel from Rd 9 (2015)

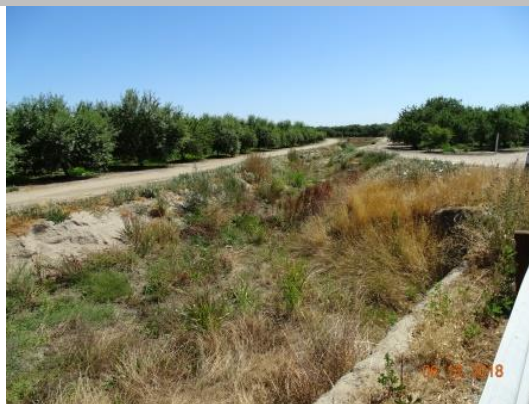
Photo 1 of 2 : CH\_2018\_NA0011\_40\_33\_20180614\_00098.jpg

Inspector Comments: Minor vegetation present that does not impede flow in the channel.

Looking upstream at the channel from Ave 25 and Washington Rd. (2018)

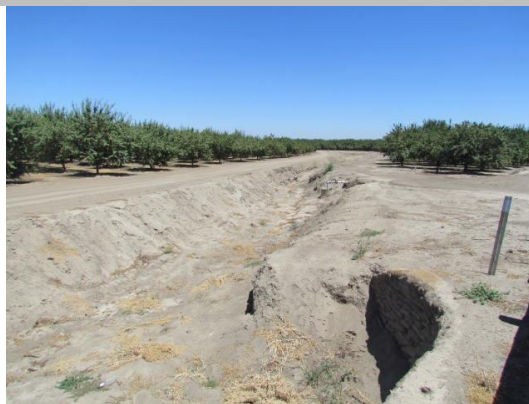
Photo 2 of 2 : CH\_2018\_NA0011\_40\_33\_20180601\_00052.jpg

Inspector Comments: Minor vegetation present that does not impede flow in the channel.

Looking east (upstream) at channel from Avenue 25 & Washington Road. (2015)

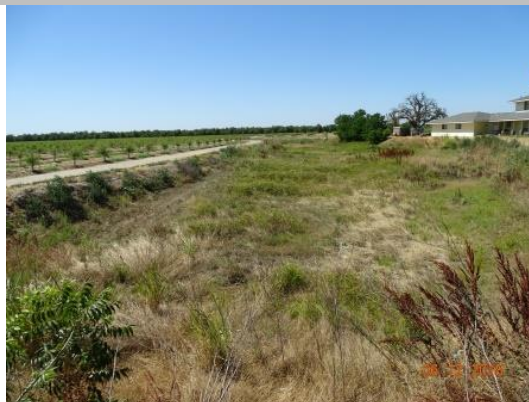
Photo 1 of 2 : CH\_2018\_NA0011\_40\_36\_20180614\_00099.jpg

Inspector Comments: Minimal vegetation is present that does not impede flow in the channel.

Looking downstream at channel from Ave 25 and Washington Rd. (2018)
